**District 7 - Road Safety Assessment
Team Findings Summary**

**SR 60 (Gulf to Bay Boulevard)
at
CR 501 (S Belcher Road)**

Section: 15 040 000 MP: 3.441

July 2014

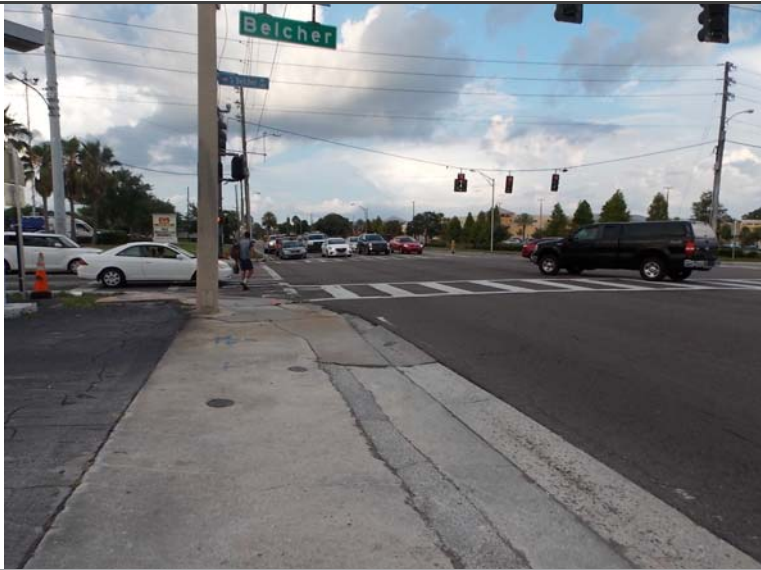
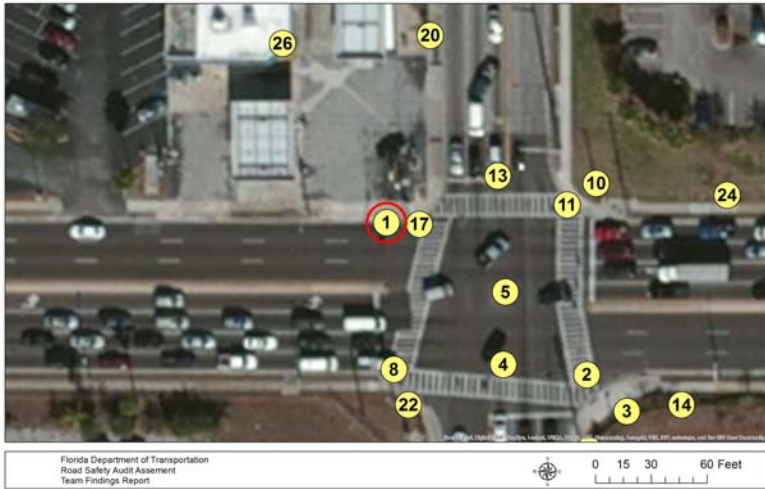
ID	Location Description:	Observation Overview:	Suggestions for Consideration:
1	Edge line on north side of west leg	Worn edge line markings	Refurbish the pavement markings

The edge line along the westbound leg on the northwest quadrant is worn.

Refurbish the section of worn pavement markings.

Maintenance office will address.

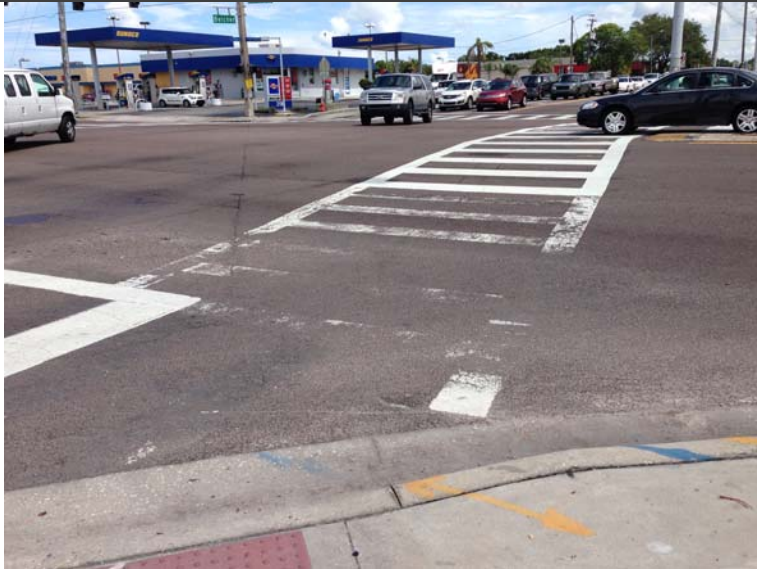
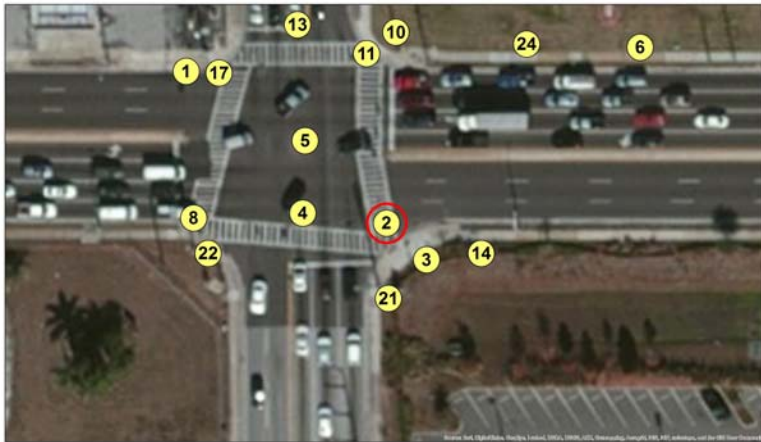
2 Crosswalks

Incomplete restriping of crosswalk and stop bar

The crosswalk at the east leg of the intersection appears to have been re-surfaced; the southern most section was not re-striped. The north most section of the stop bar for the westbound was not re-striped concurrent with the recent pavement marking refurbish.

Complete the markings

Refurbish the section of worn pavement markings.

Maintenance office will address.

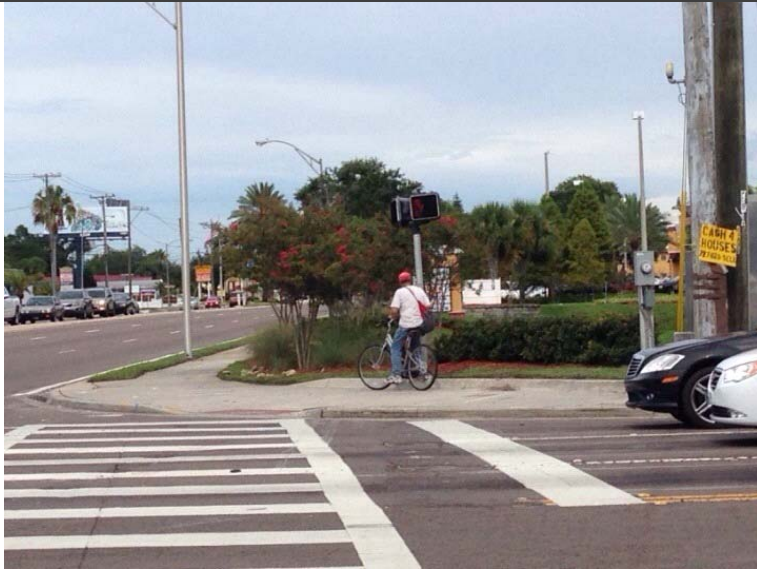
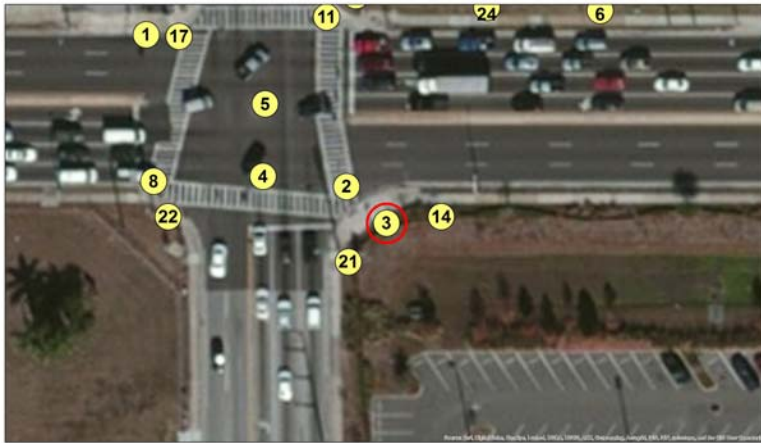
3 Southeast quadrant

Pedestrian indication rotated

The pedestrian signal indication located in the southeast quadrant of the intersection is not properly aligned with the south leg crosswalk. It appears that either the post was knocked off center during a collision, or that the pedestrian indication was not re-aligned concurrent with the installation of the eastbound right-turn lane, which shifted the sidewalk to the south along the southwest quadrant.

Align with crosswalk

Re-align the pedestrian indications with the crosswalk on the south leg of the intersection for the west to east pedestrian crossing.

FDOT will coordinate the improvement with the City of Clearwater.

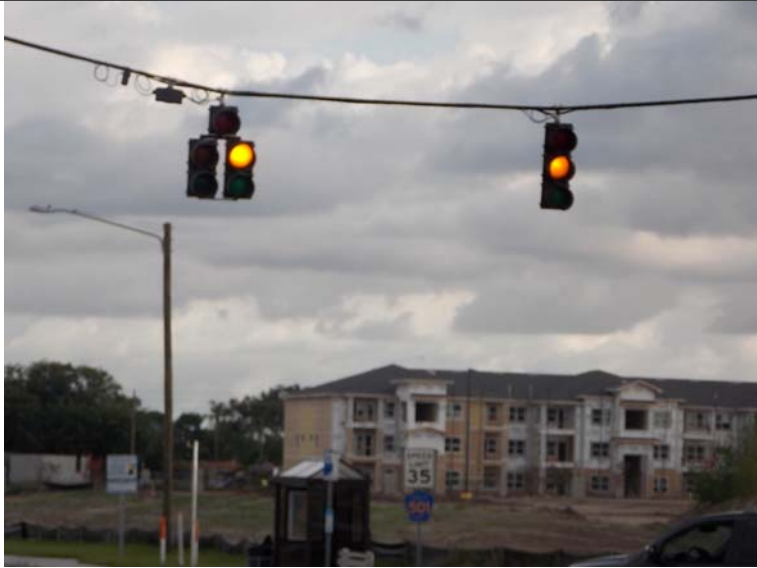
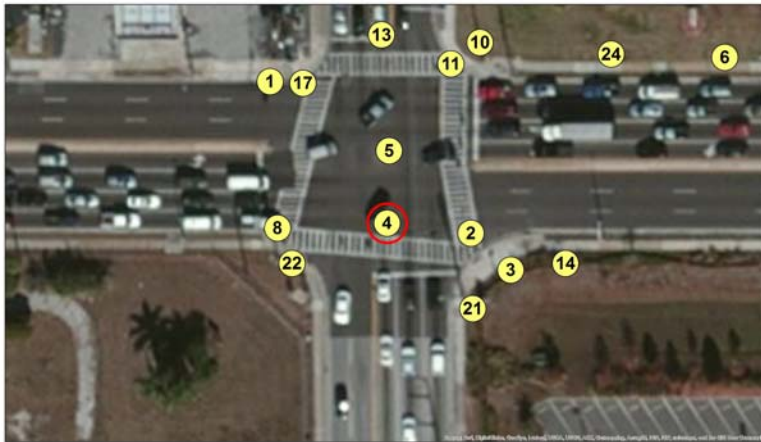
The protected-permissive left-turn (green arrow and green ball) phases allow for possible pedestrian / vehicle conflicts during the permissive (green ball) left-turn signal phase.

Replace the 5-section head with a 4-section head with a flashing yellow arrow. Also study the intersection to determine feasibility of converting the left-turn phases to protected only by time of day in order to reduce possible conflicts with turning vehicles and pedestrians during the peak times.

FDOT will coordinate the improvement with the City of Clearwater.

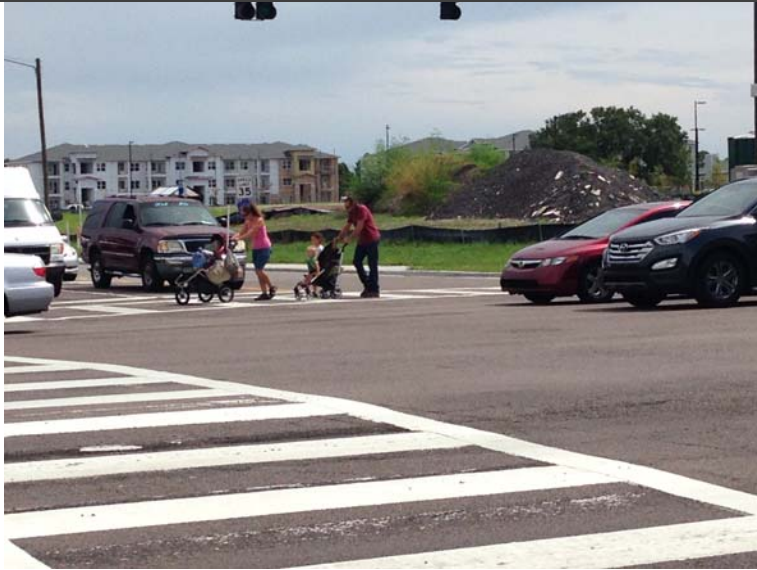
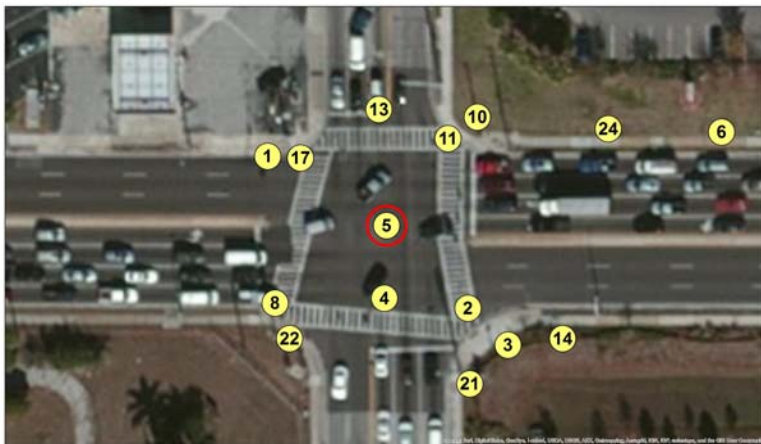
5 Signal timing

Long cycle lengths

Pedestrians were observed pushing the pedestrian button at the intersection and completing their crossing against the do not walk before their walk phase comes up. The walk phase across Belcher Road is on minimum pedestrian recall.

Optimize cycle length

Evaluate the signal operation to determine the optimal cycle length for all users. Adjust the cycle length accordingly.

Traffic Operations will evaluate/study the cycle lengths and adjust as necessary.

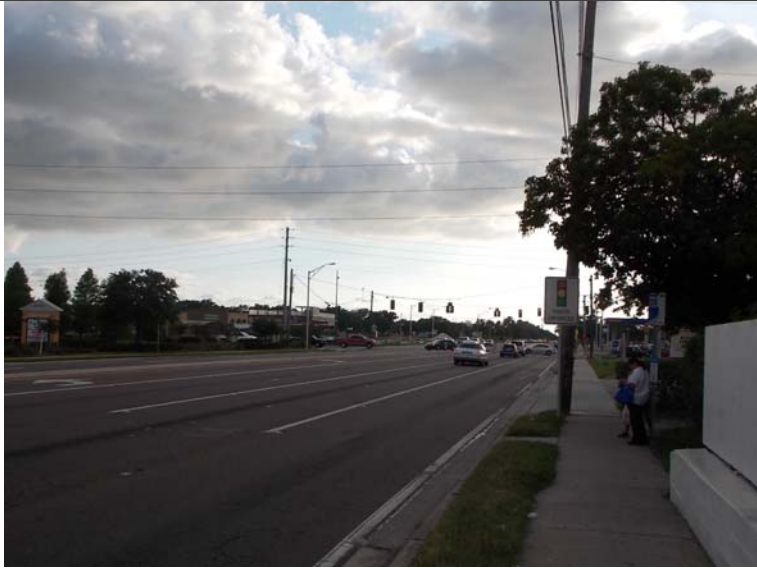
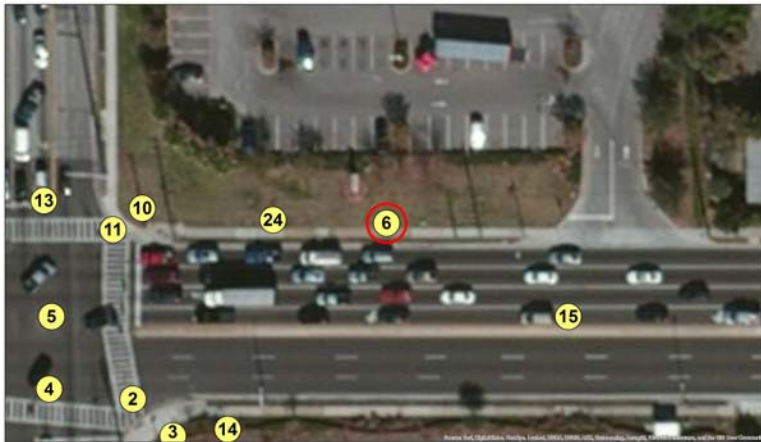
6 Eastbound and westbound approaches

Photo enforcement signs

The photo enforcement signs on the eastbound and westbound approaches are located near the enforcement cameras.

Increase the conspicuity of the signs

Better advanced notification of the red light cameras at this intersection needs to be provided.

FDOT will review and adjust location of signs or add additional signs as needed.

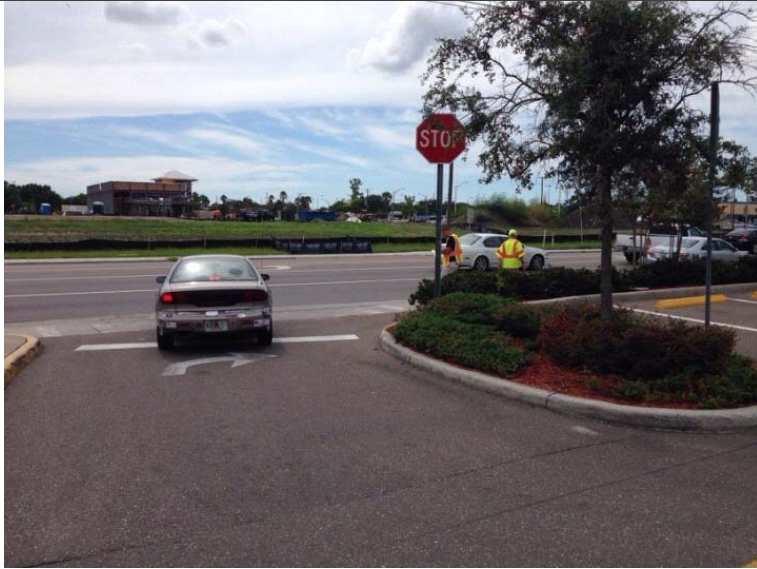
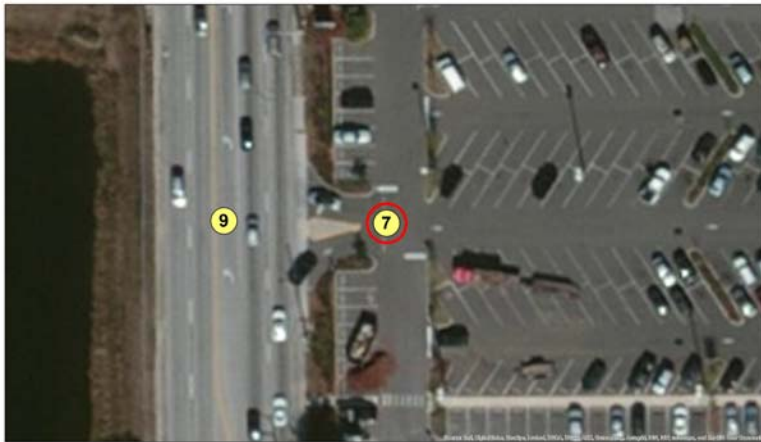
7 Publix driveway

No turn restrictions

The team observed that there are no turn restriction signs at the right-in / right-out driveway for Publix along Belcher Road south of Gulf to Bay Boulevard.

Provide right-turn only sign

Provide right-turn only signs.

Pinellas County will coordinate with the City of Clearwater.

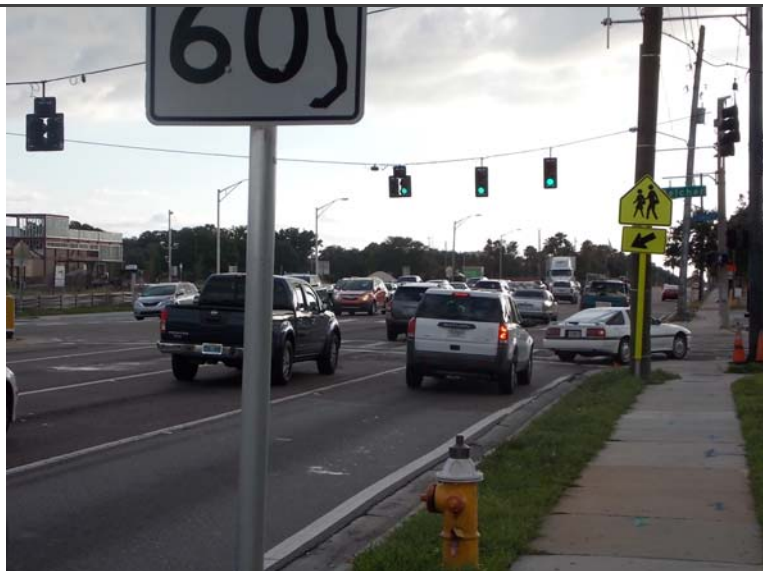
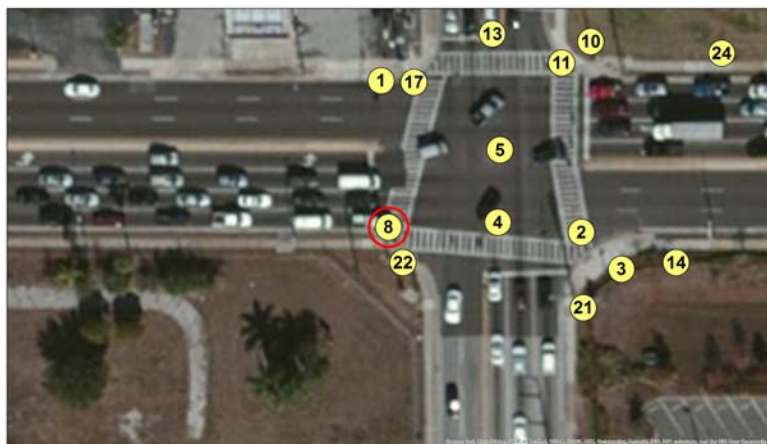
8 All four quadrants

School crossing signs

There are school pedestrian crossing signs at the intersection. City of Clearwater staff informed the team that students will no longer be permitted to cross at this intersection, and will be bused instead in the interest of safety. There will no longer be an official school crossing at the intersection and the crossing guards will be removed.

Replace with turning vehicles yield to pedestrians (R10-15)

Observe the crossings at the signal during the school year to ensure there are no students crossings. If there are none, replace the school crossing signs with R10-15 (turning vehicles yield to pedestrian) signs.

Action:
Will obtain confirmation from the School Board of the zoning / busing change. Will review the intersection during the school year.

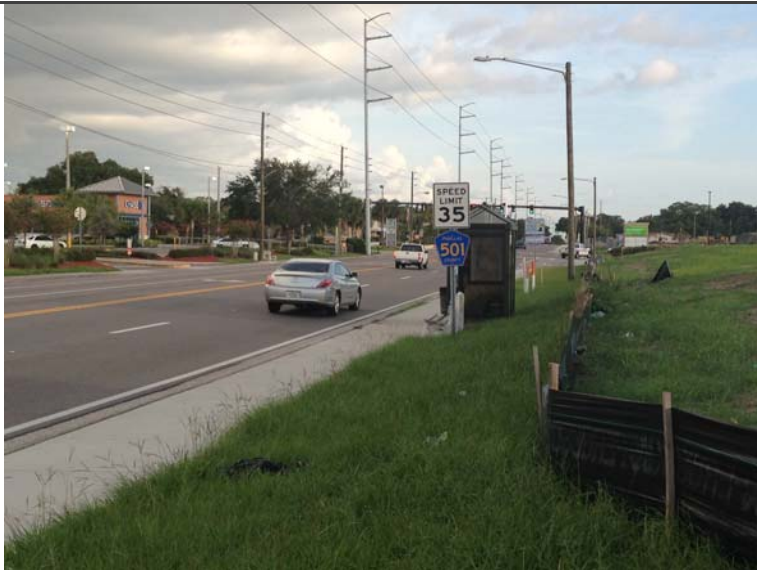
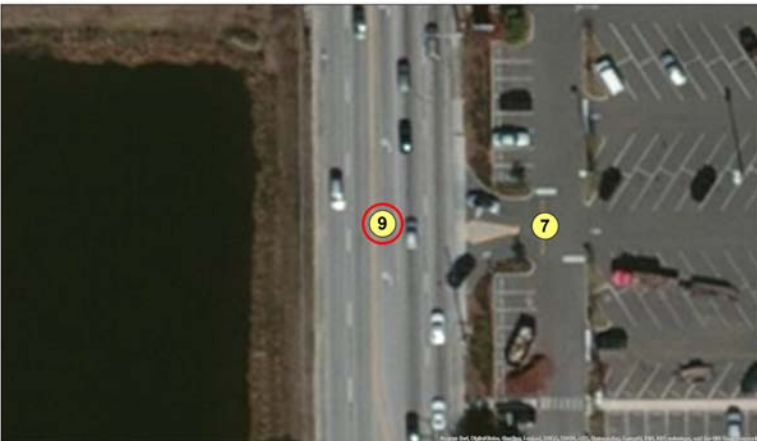
9	Publix entrance along Belcher Road	Left turns being made into the right-in / right-out driveway	Prohibit southbound left-turns
---	------------------------------------	--------------------------------------------------------------	--------------------------------

Southbound vehicles were observed making left-turns into the Publix driveway along Belcher Road; the driveway is intended to operate as a right-in / right-out driveway with a raised separator. Southbound left-turns stopping in the thru lane to turn left into the shopping plaza create friction with other southbound vehicles.

Evaluate strategies to prohibit left-turn access including but not limited to providing no left-turn (R3-2) signs along the southbound leg along Belcher Road and/or provide a traffic separator.

Pinellas County will coordinate with the City of Clearwater.

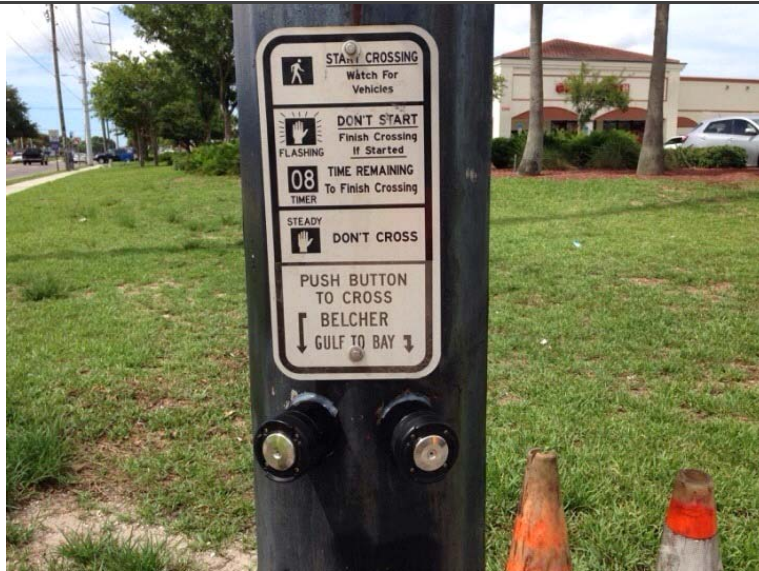
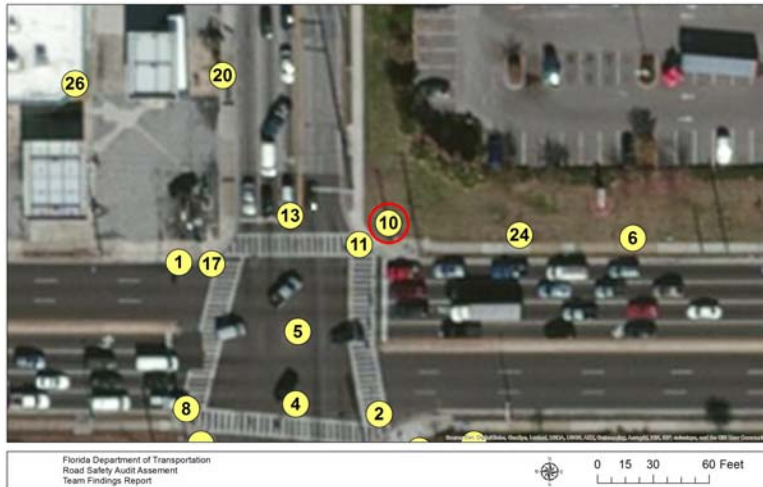
Pedestrians and bicyclist were observed pushing both push buttons when waiting to cross either Gulf to Bay Boulevard or Belcher Road. Some pedestrians indicated that due to the proximity of the buttons, they do not know which button to push.

In the short term, separate the bush buttons and signs on the existing signal pole. Concurrent with the signal rebuild, replace the single push button instruction sign with separate buttons and signs denoting the name of the intersection that each button controls respectively. Also consider installing feedback push buttons to reassure that buttons have been activated.

FDOT will coordinate with the City of Clearwater.

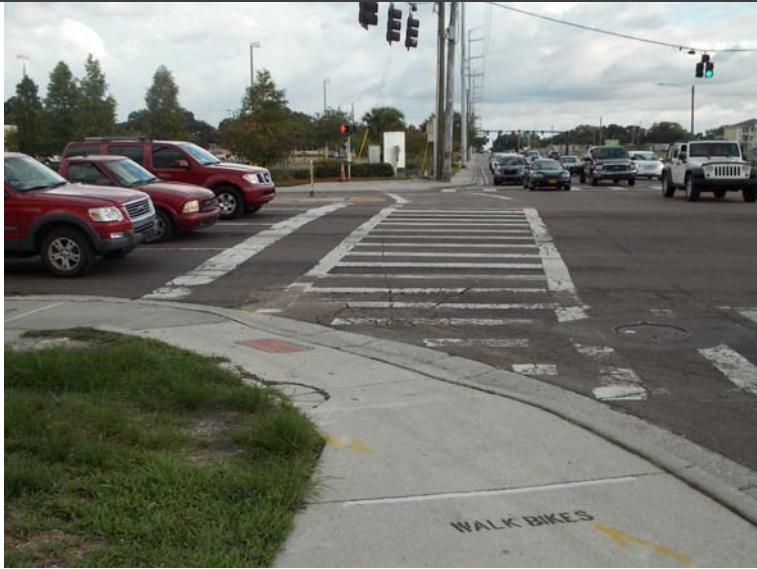
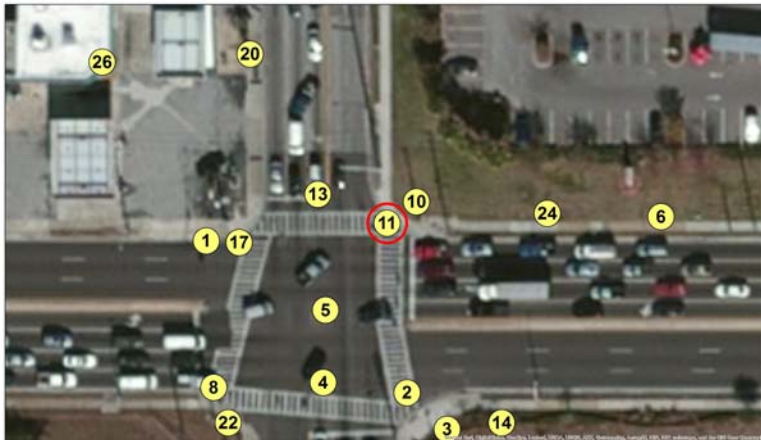
11 Northeast ramp

No truncated domes

The ramp at the northeast leg of the intersection does not have a tactile surface pad. There is also a utility access panel at the ramp.

Provide tactile surface pad

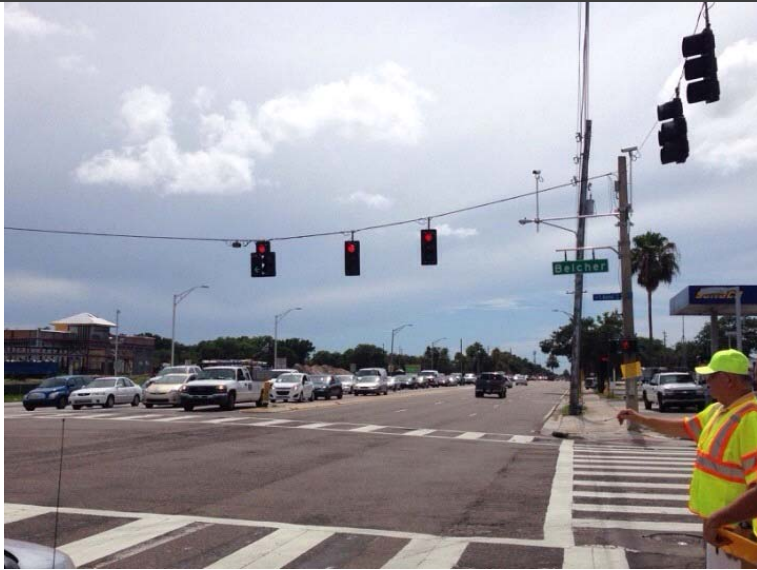
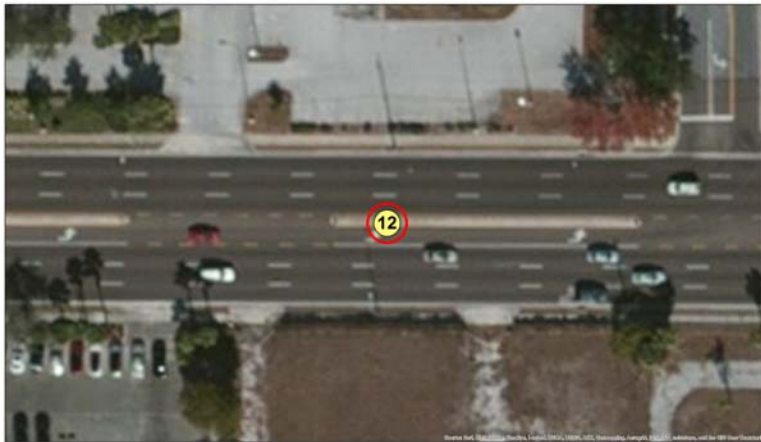
An advanced intersection sign for Belcher Road exists heading westbound. However, similar signs are not present heading eastbound, northbound, or southbound approaching this intersection.

Provide advance street name signs

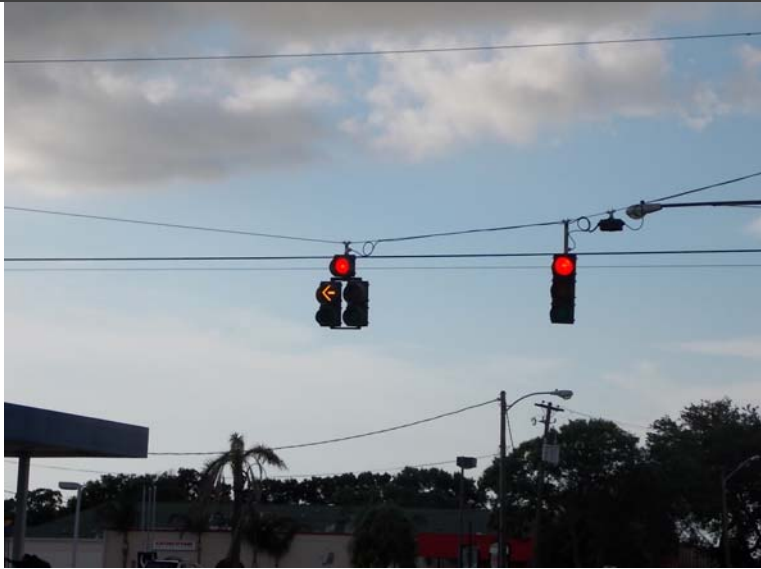
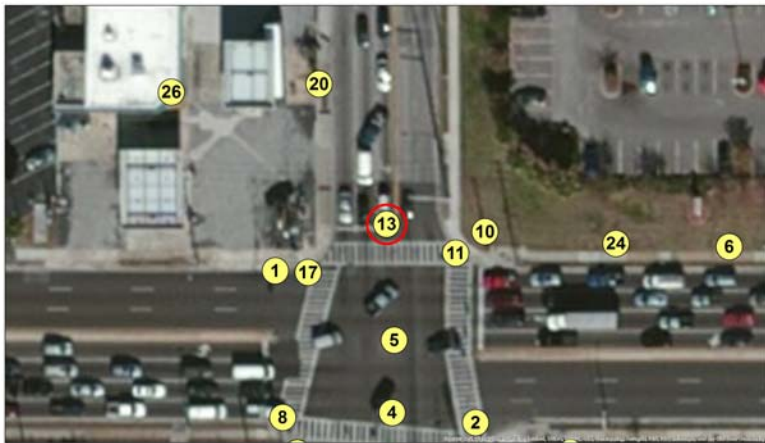
ID	Location Description:	Observation Overview:	Suggestions for Consideration:
13	Northbound and southbound approaches	No back plates on signal heads	Provide retro-reflective back plates

There are no back plates for the traffic signal heads on the northbound and southbound approaches.

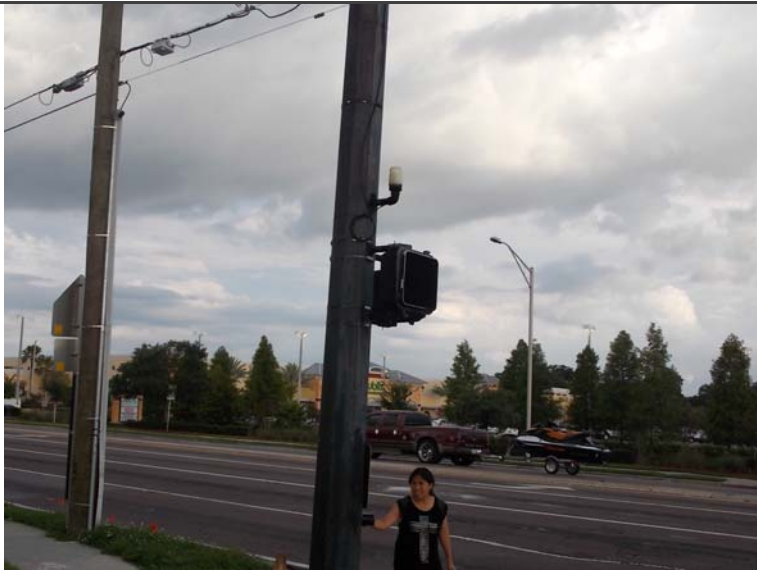
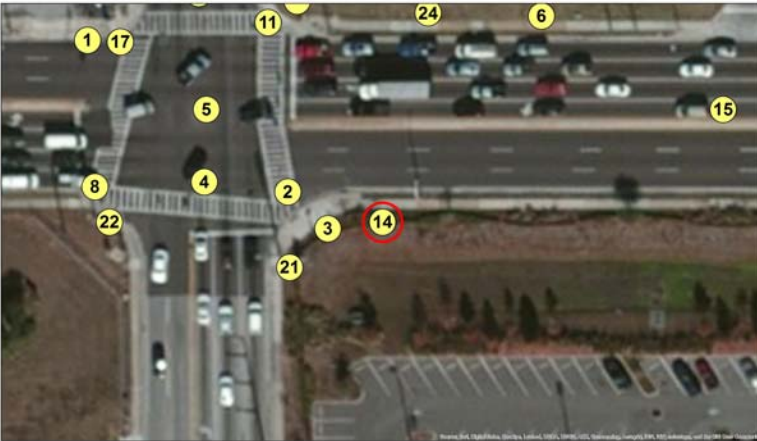
Red light enforcement lights below signal heads need replaced

The police officers indicated that the limited right-of-way and curbs make it challenging to do safe red light running enforcement at this intersection; there is nowhere to safely park. There are incandescent enforcement lights mounted near the pedestrian signal heads on the signal poles.

Upgrade the enforcement lights to LED

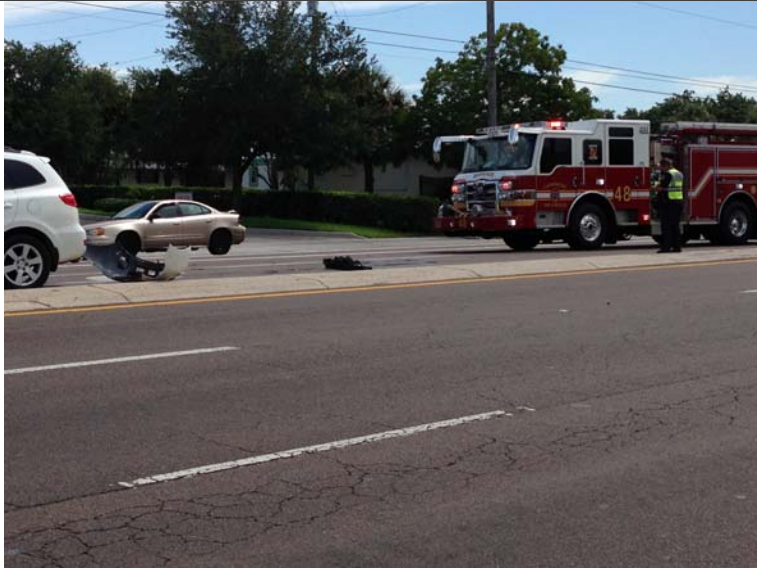
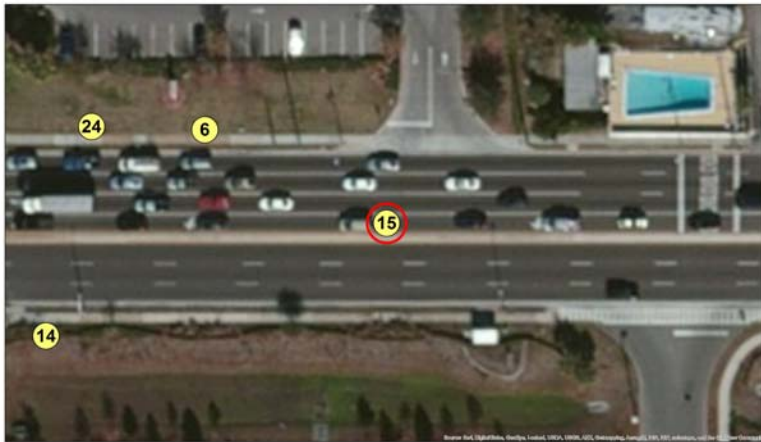
Vehicles were observed unable to access the left-turn lane due to queue from the thru lane.

Extend the length of the left-turn

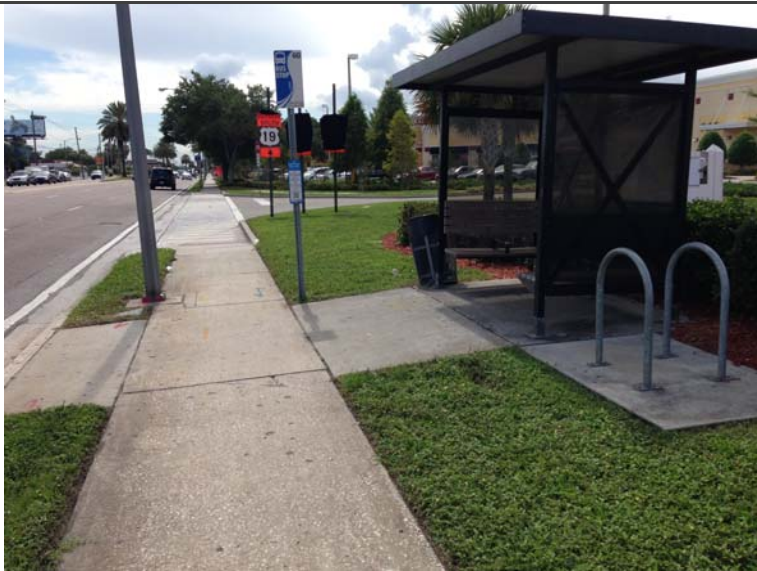
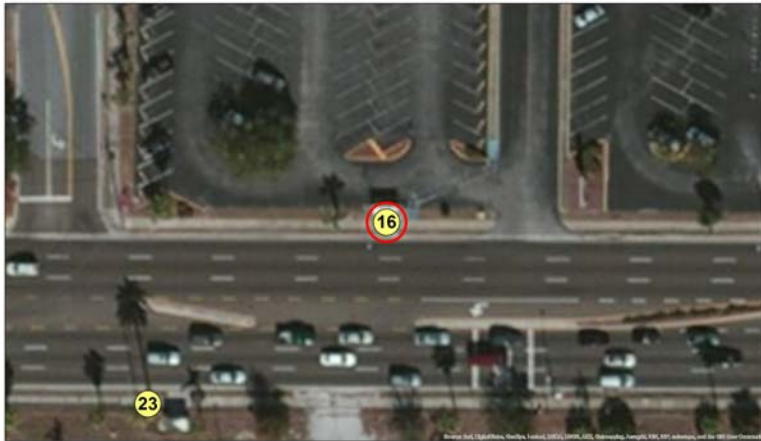
Pedestrians were observed crossing mid-block at the transit stops located away from the signalized intersection of Gulf to Bay Boulevard and Belcher Road.

Relocate closer to signalized crossings

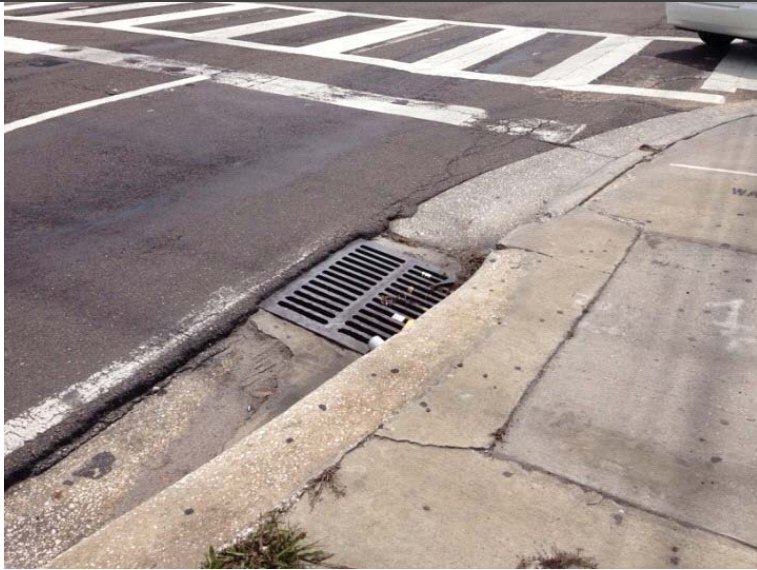
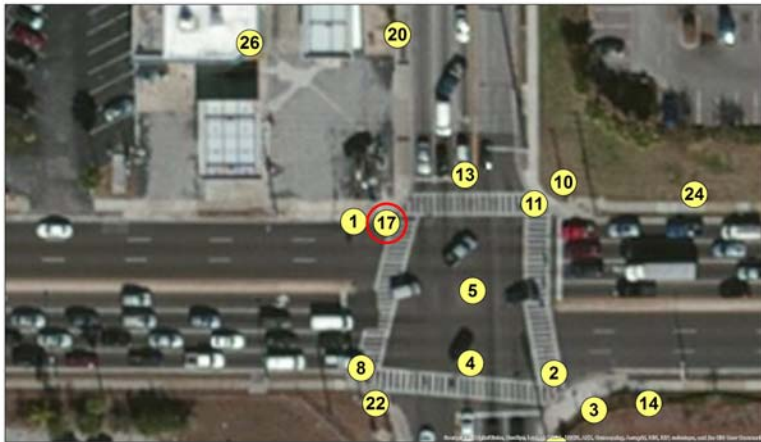
Ponding was observed at the intersection while it rained during a field review; the drainage appears to be inadequate to handle heavy rainfall. Additionally, the drainage location near the apex of the curb prevent two pedestrian ramps from being built.

Upgrade for improved drainage

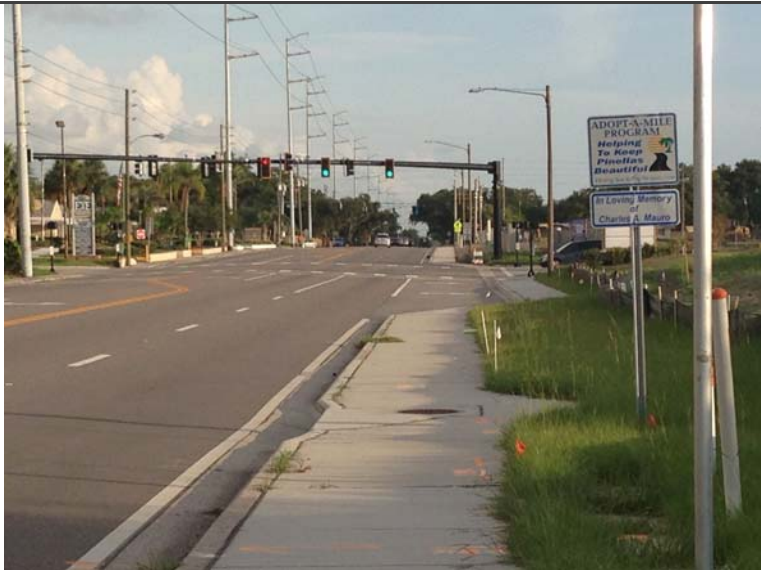
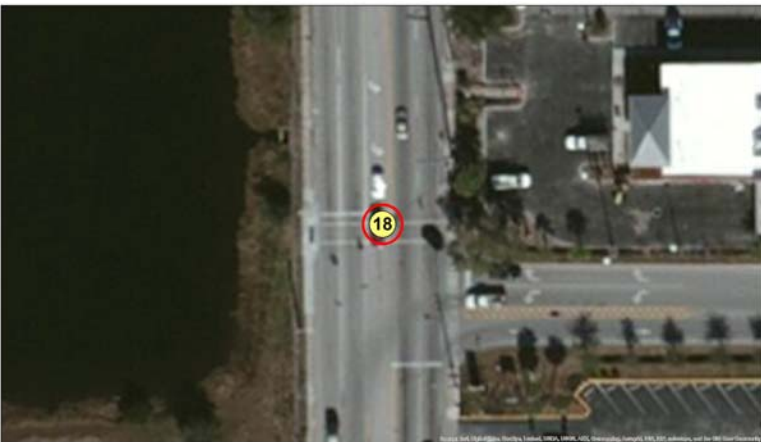
The signalized intersection south of Gulf to Bay Boulevard and Belcher Road has protected only (green arrow only) phases for the southbound left-turn. The team noted sufficient gaps during for the opposing thru movements that a permissive (green ball) left-turn could have been made.

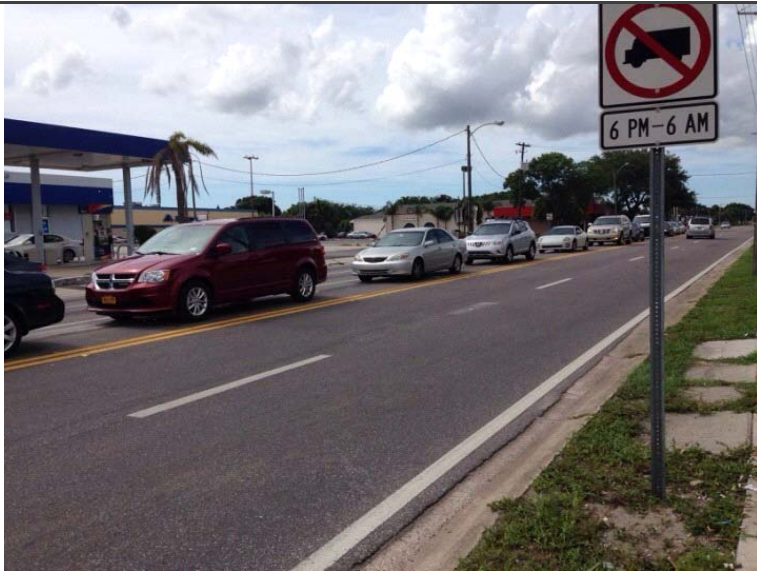
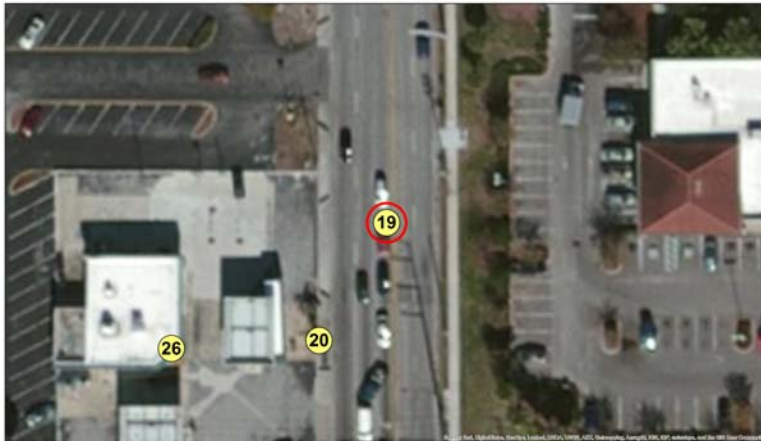
The beginning of the left-turn lane is not very clearly defined causing driver confusion. Unnecessary lane changes were observed by southbound drivers.

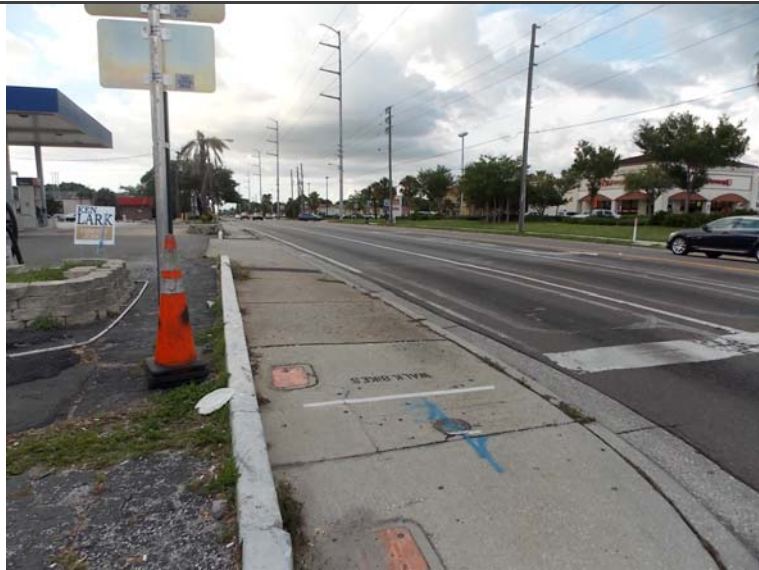
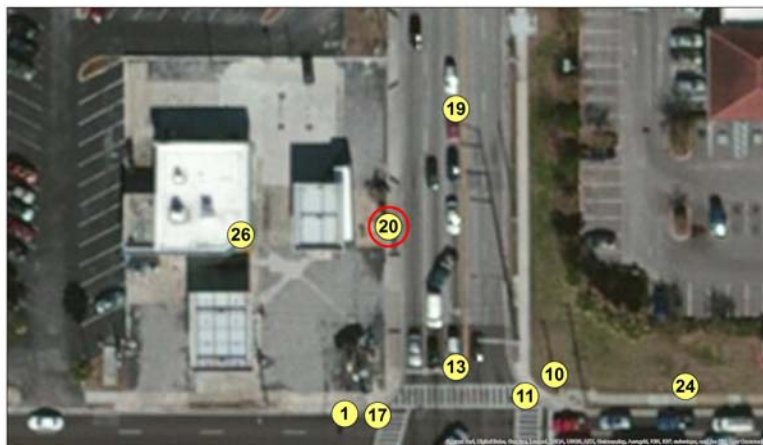
20	Sidewalk on west side of Belcher on north leg of the intersection	Not up to ADA standard	Upgrade to meet standard
----	-------------------------------------------------------------------	------------------------	--------------------------

The sidewalk along the west side of the north leg of the intersection does not appear to be up to ADA standards. The truncated dome pads along the sidewalk at driveways along the segment denote that the intersection of the sidewalk with the driveway is dominated by the driveway; that it is intended for vehicles. A preferable configuration has the sidewalk extending through the driveway.

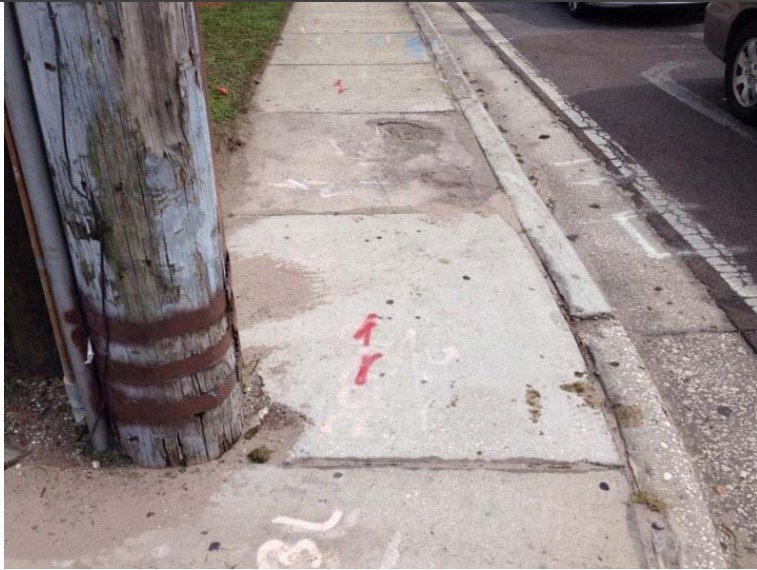
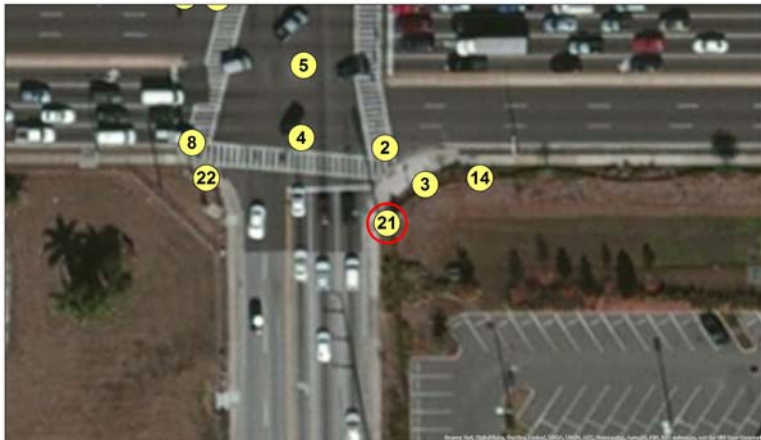
The sidewalk narrows due to utility poles on the southeast quadrant. Also, there are ruts in the sidewalk, its condition appears to be deteriorating.

Widen sidewalk

Replace the deteriorating sidewalk segment in poor condition and widen the sidewalk, in the long term, to provide the minimum required width per ADA standards.

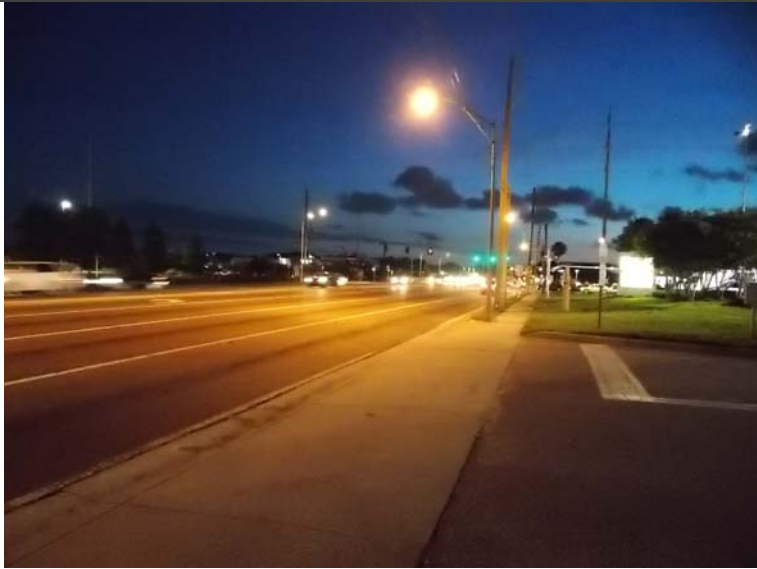
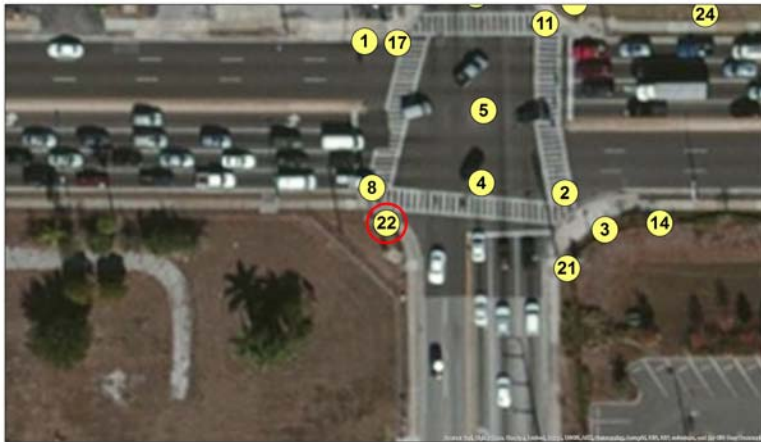
It was noted during the nighttime review that three of the four quadrants have luminaries.

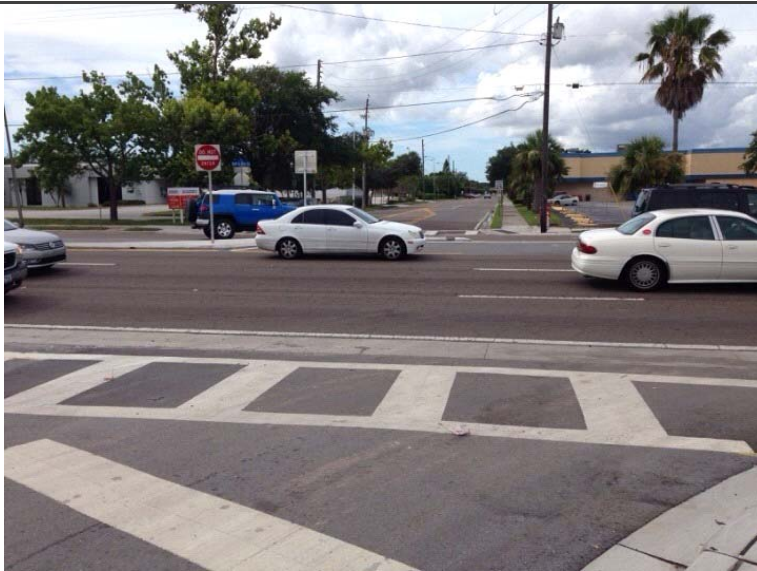
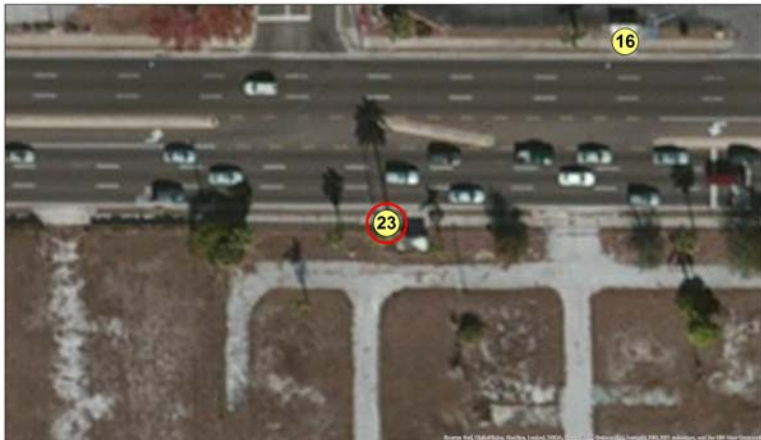
Pedestrians were observed crossing Gulf to Bay Boulevard mid-block to the east of the right-in / right-out entrance to Walmart Market. Also, westbound left-turn movements into this same driveway were observed turning though the stopped eastbound traffic queue at this signal.

Pedestrian crossing study

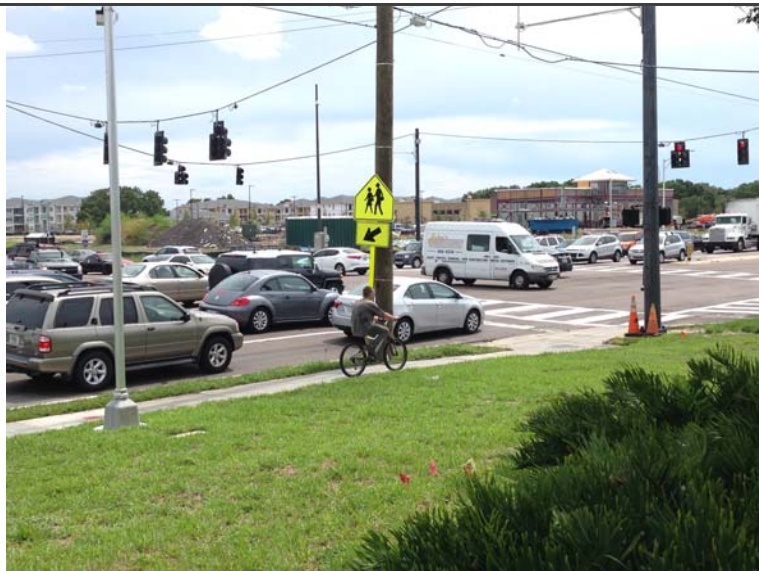
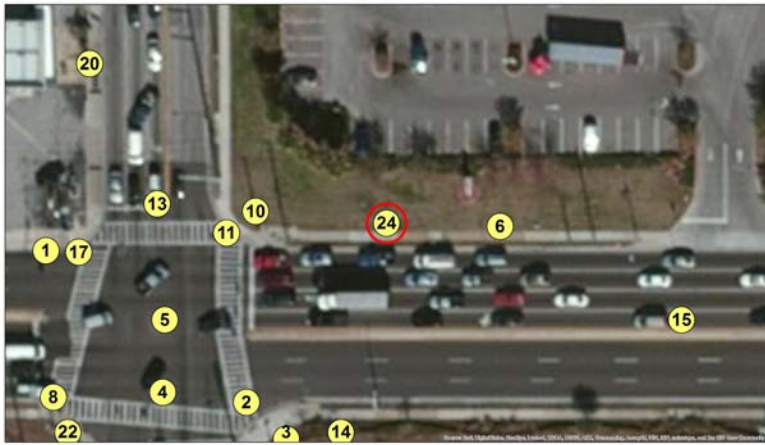
Although westbound right-turn volumes exceed 100 vehicles per hour during peak travel periods, there is no westbound right-turn lane at this intersection. Right-turning vehicles turning out of the shared thru-right lane may turn at greater speeds out of concern for rear-end crash conflicts and therefore be less able to yield to pedestrians crossing the north leg of the intersection. Drivers following too closely to right-turning vehicles may cause rear-end crashes—especially if a driver stops short to yield to a pedestrian and/or may cause sideswipe crashes if they change lanes unexpectedly to avoid leading vehicles that are slowing to turn.

Based on visual inspection of the area, it appears feasible to construct a west-bound right turn lane approximately 200ft in length (including taper). During higher-volume periods of the day, traffic will be blocked from entering this lane by the thru queues limiting the capacity benefit; however, the lane will provide a space for turning vehicles to safely decelerate before turning onto northbound Belcher Road which is the primary purpose of the lane from a safety perspective. As noted in the Observations above, the ability to decelerate to a safe turning speed without concern of being rear-ended by thru traffic will help right-turning drivers to be more conscious of pedestrians crossing Belcher. Installation of R10-15 (right turn yield to pedestrian) signs and or staggered stop bar will help to reinforce this behavior.

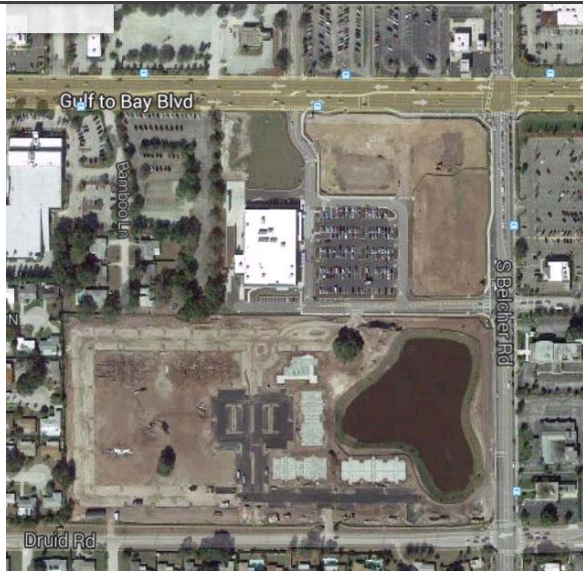
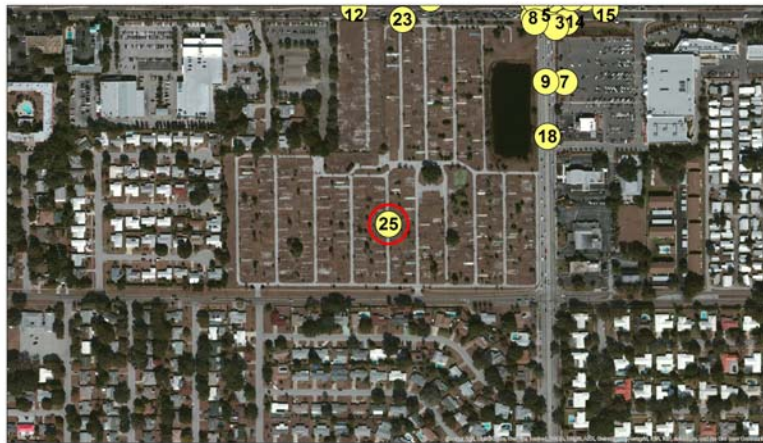
The southwest quadrant is under construction.

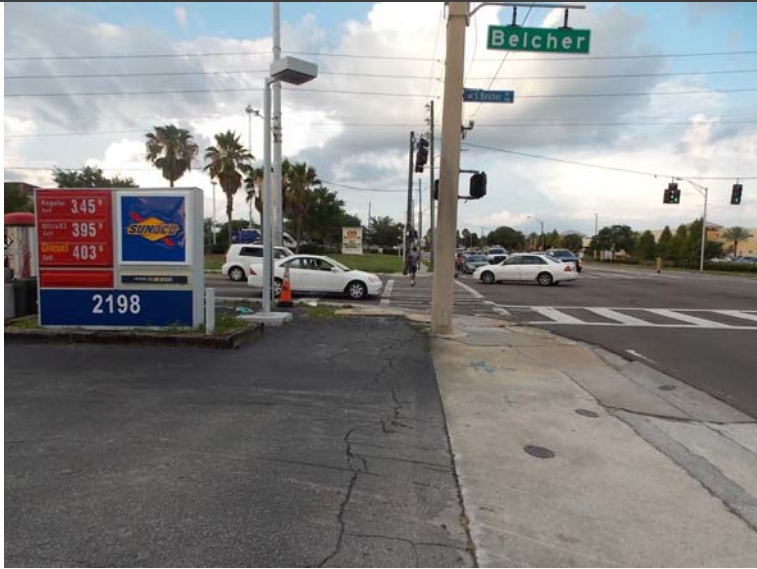
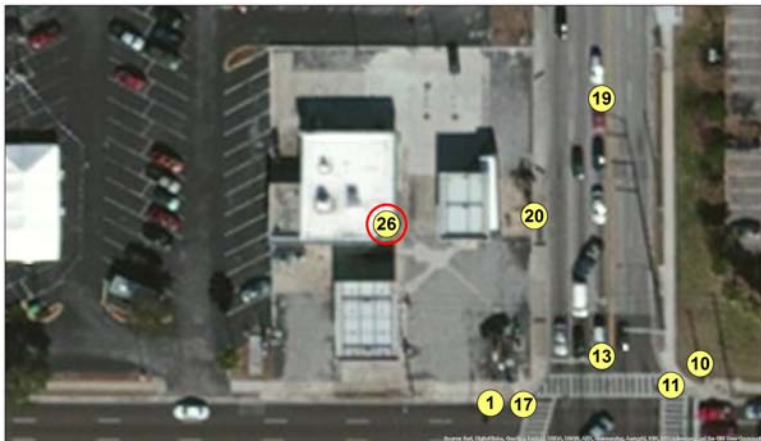
Egress and ingress through the driveways for the gas station on the northwest quadrant of the intersection creates friction at the signalized intersection due to their near proximity to the signal. The parcel does not have access to the adjacent parcels; it's only access is from Gulf to Bay Boulevard and Belcher Road.
