Ridgemoor Boulevard Over Brooker Creek Bridge Replacement FPID 445437-1

By FDOT, Presenter Nate Willbur, P.E.

Ridgemoor Blvd over Brooker Creek

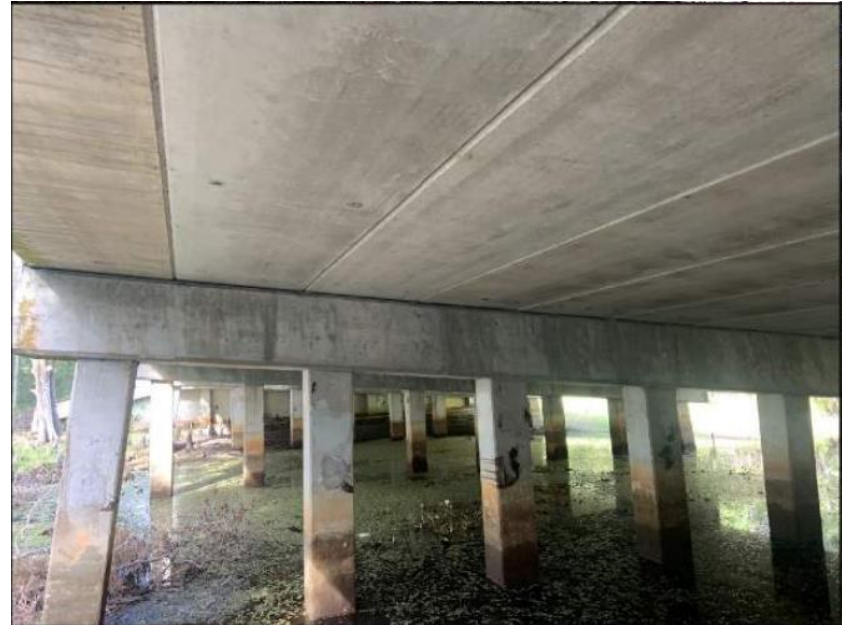
History

- In 2013, FDOT determined this bridge was Scour Critical
- Yearly inspection and after severe storms
- Prepare a Contingency in case of Emergency Closure
- Determined it needed to be Replaced

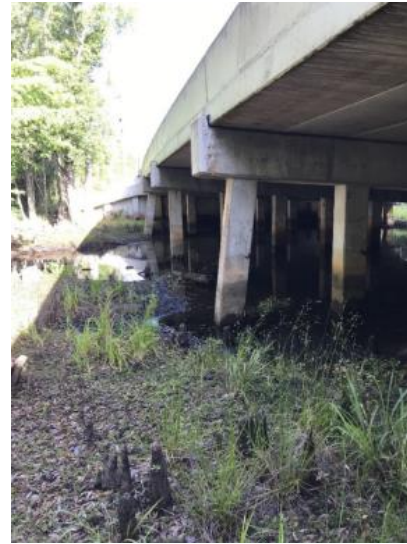
Scour

- This Bridge is Scour Critical
- Increased Risk of Scour

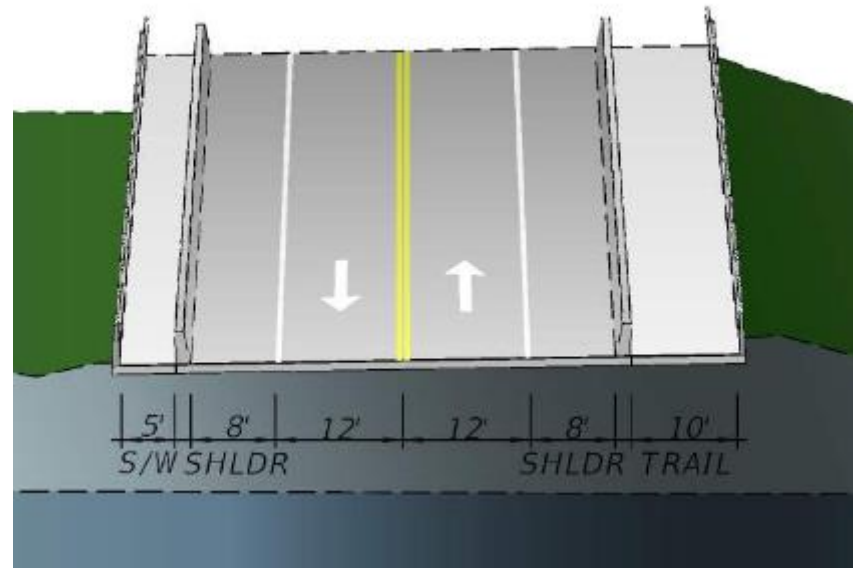
New Bridge

- Replace within the same footprint.
- Adding a 10-foot Multi-Use Trail
- Different Bridge Type
 - Concrete Precast Prestressed Bridge

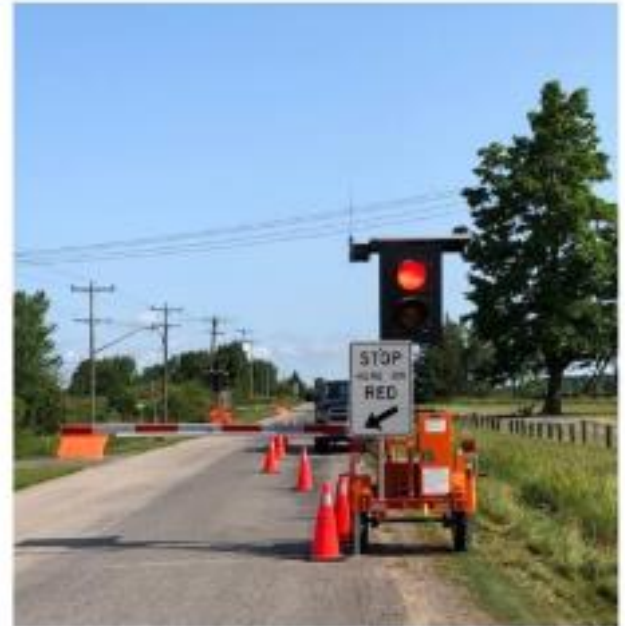
Construction

- Expected 1 ½ to 2 years of Construction
- The new bridge is being built in phases
- Use of Automated Flagger Expected
